7-13-13 INCIDENT RELEASE – SUMMARY OF POST INCIDENT EVENTS

HERITAGE THERMAL SERVICES

EAST LIVERPOOL, OH

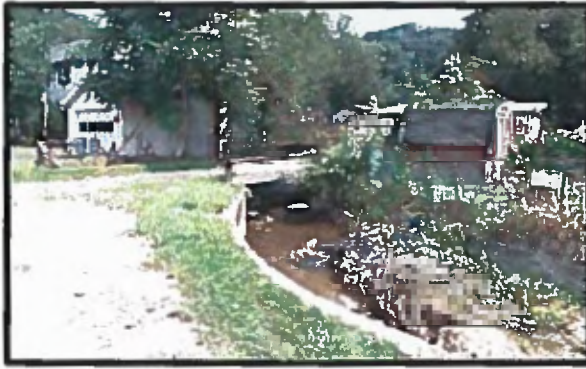
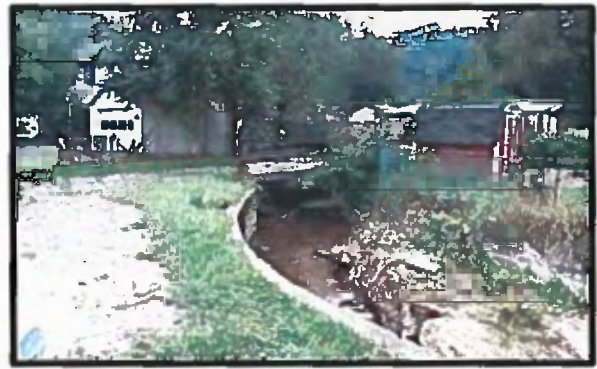
Images 4 and 5 – Before and after images of creek crossing on Virginia Avenue

During downtime, ERS crews with HES and HTS personnel removed trash and debris from the creek bed along Virginia Avenue. The removal of trash and debris from the creek bed was unrelated to the ash incident. A total of three (3) trash bags were filled with debris from the previous flooding the community had experienced due to heavy rainfall.

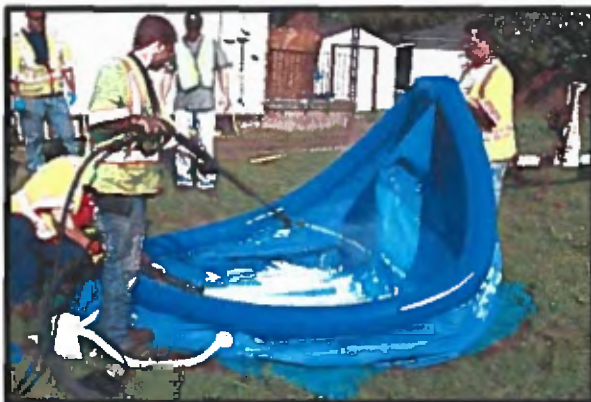
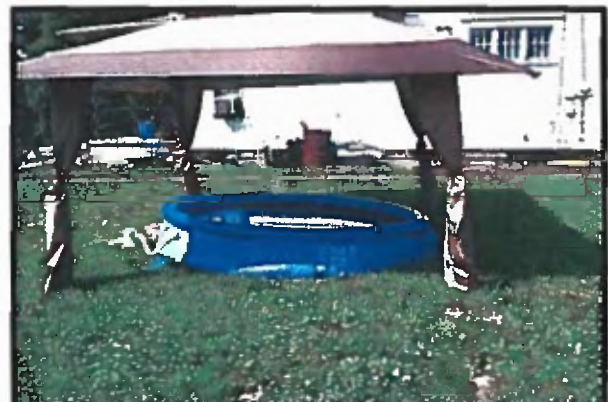
Images 6 and 7 – Crews cleaning children's swimming pool on Ohio Street

Crews cleaned one (1) above-ground swimming pool, six (6) houses, six (6) porches, and two (2) garages. Approximately 6,720 gallons of pool water were drained with the vac-truck and emptied in to the sump at the HTS facility. HTS with HES personnel also took two (2) pool water samples per the request of homeowners. These samples were taken back to the HTS laboratory for analysis (both samples came back with normal pool water characteristics). HES personnel also purchased eight (8) 50-lb bags of play sand from Tractor Supply Company in order to replace sand in a child's play box. The original sand in the play box was disposed of. A HTS Press Release was submitted to the public (see Appendix A – Press Release Information).

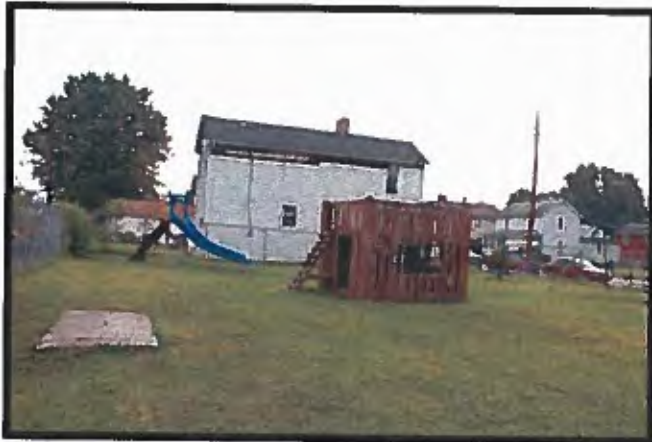
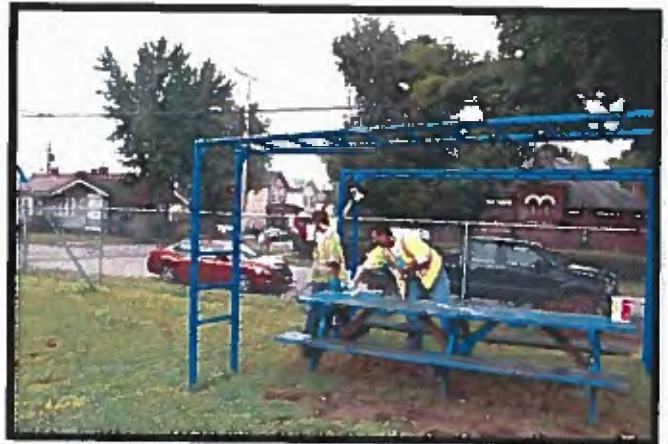
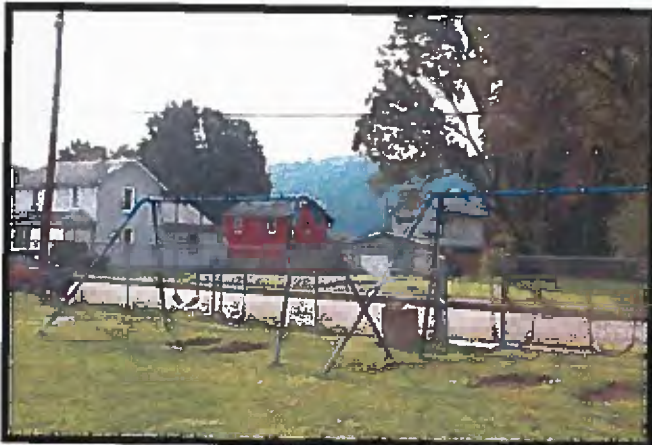
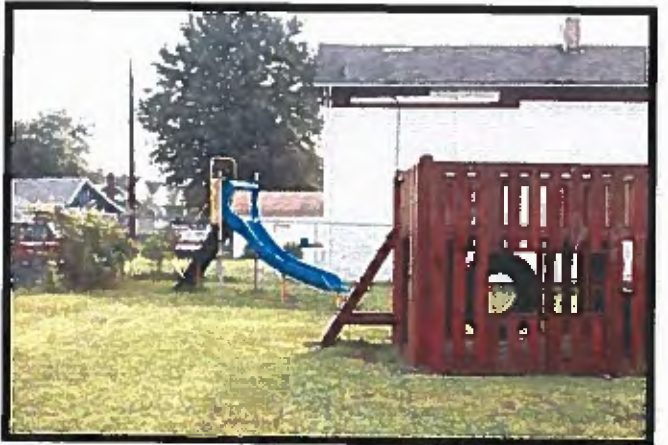
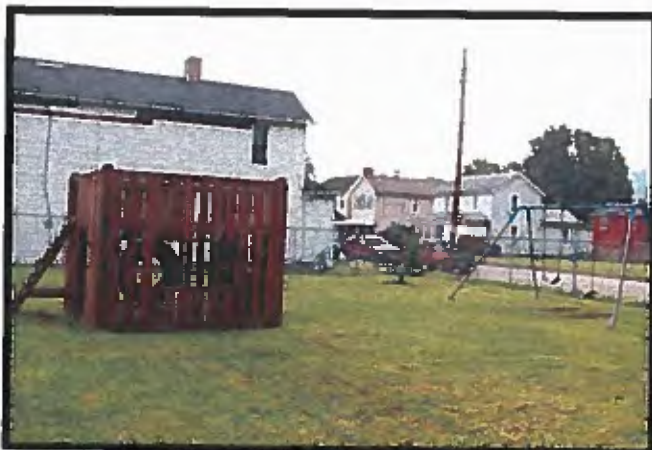
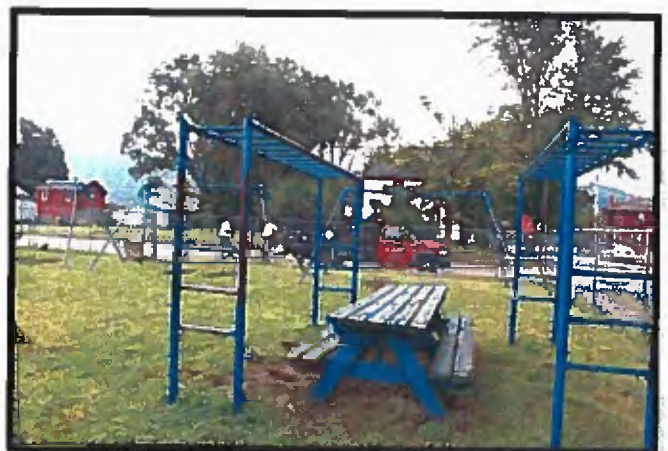
Address: Community Playground (St. George and Mulberry)

Before Photographs

After Photographs

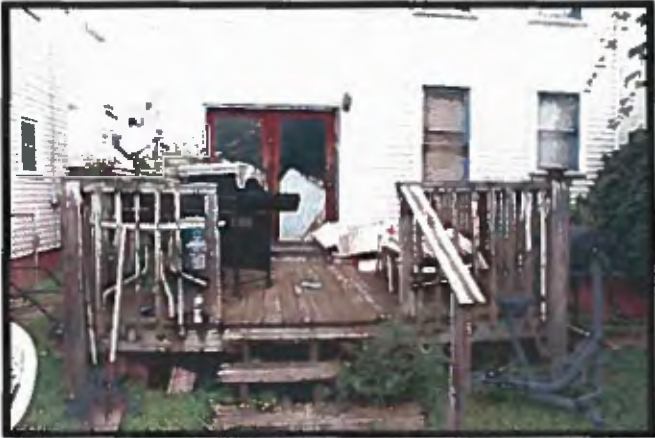
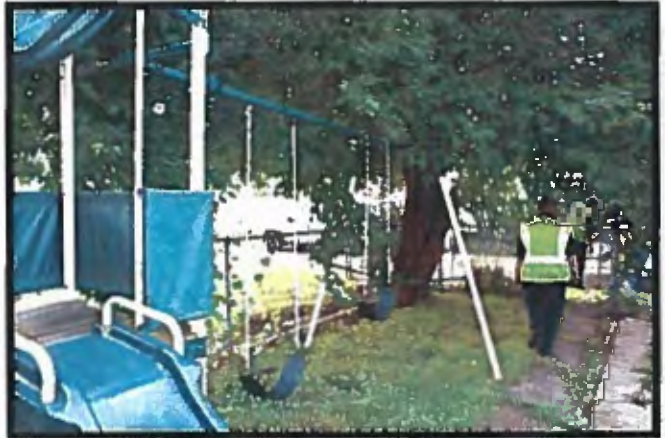
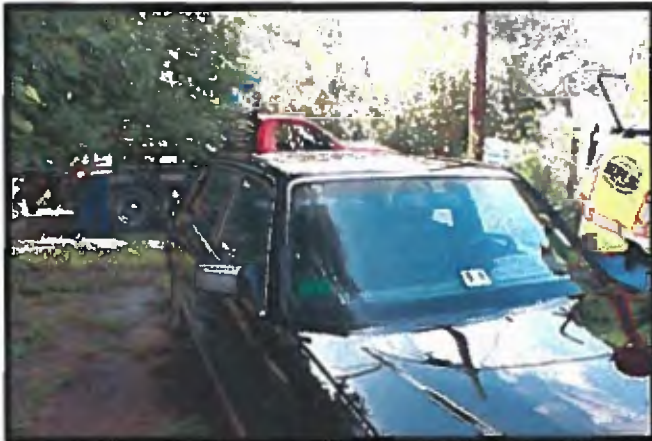
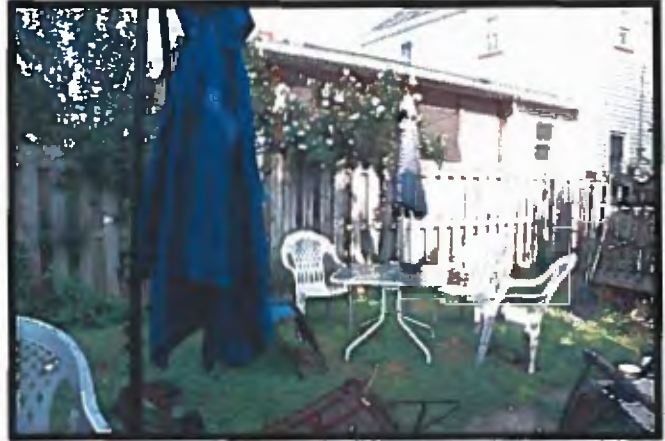
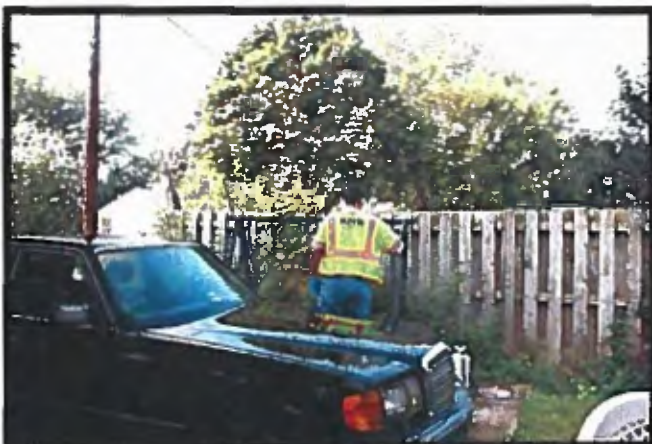
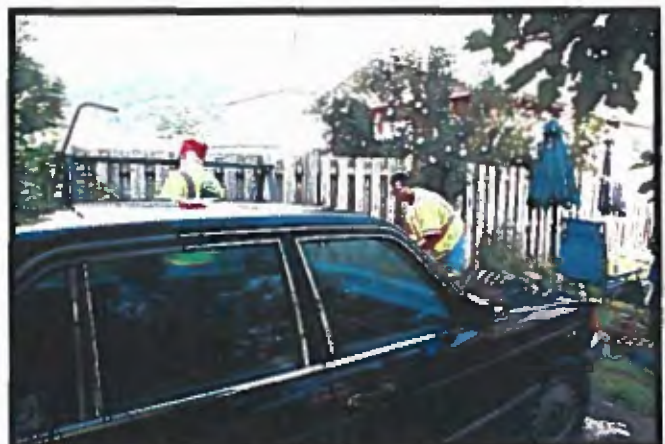
Address: 1058 St. George

Before Photographs

After Photographs

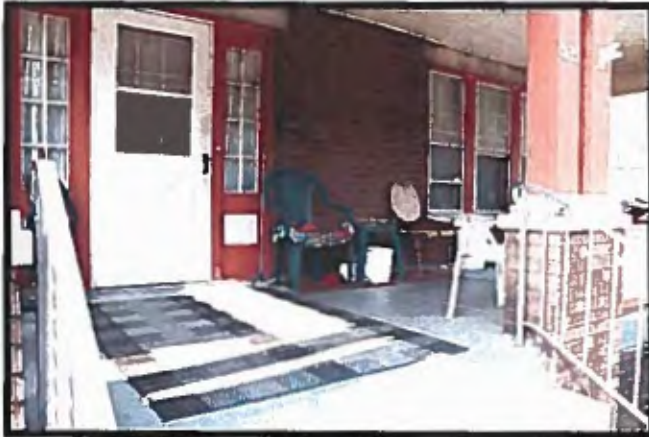
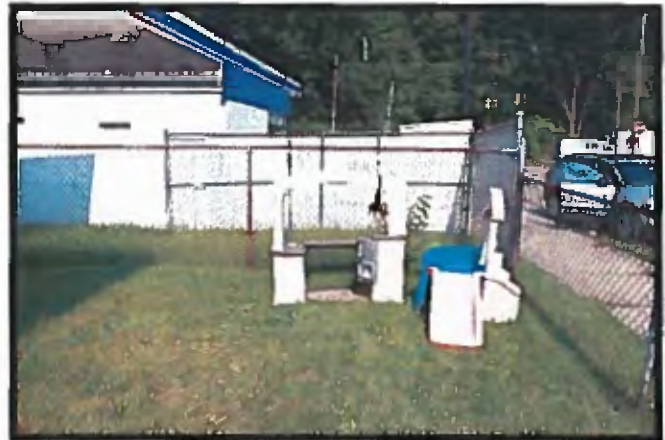
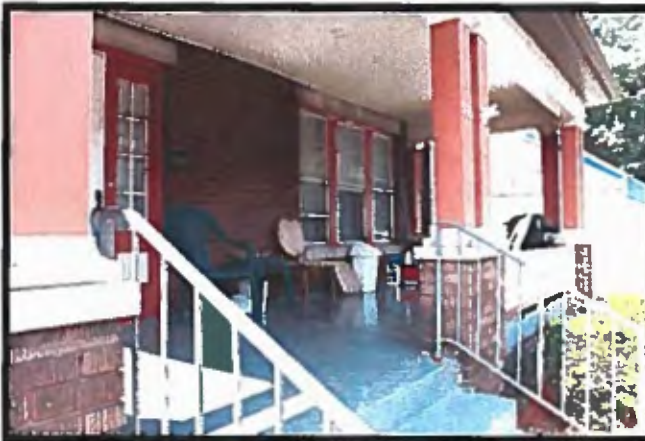
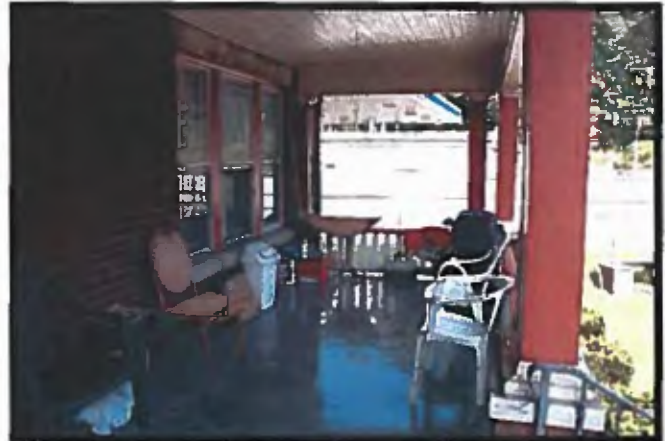
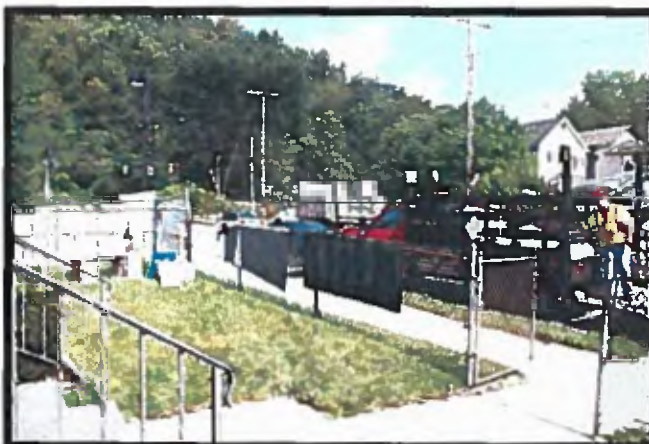
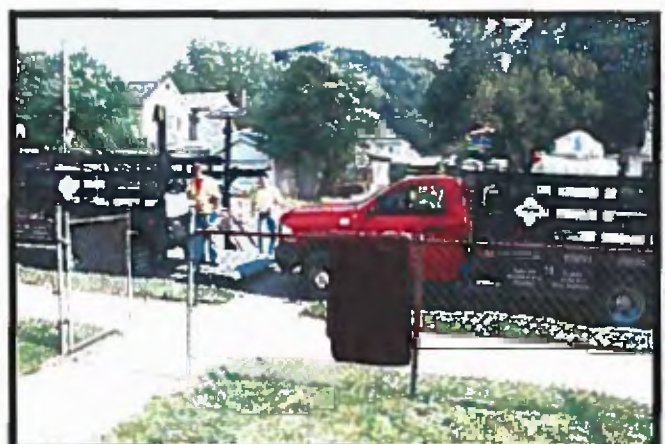
Address: 535 Virginia Ave

Before Photographs

After Photographs

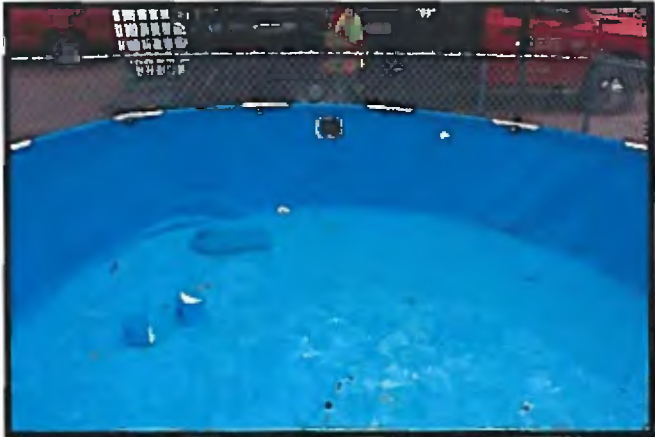
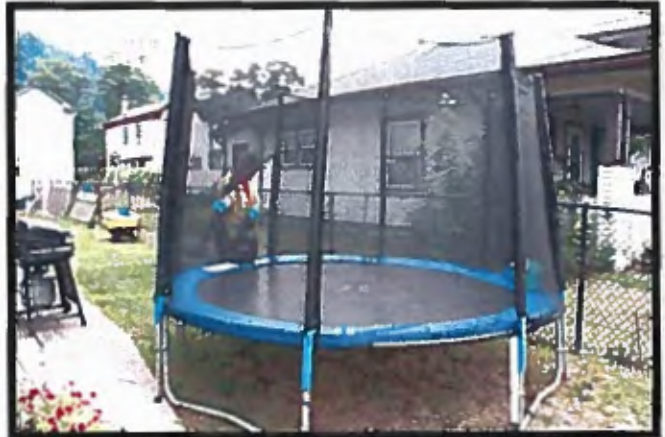
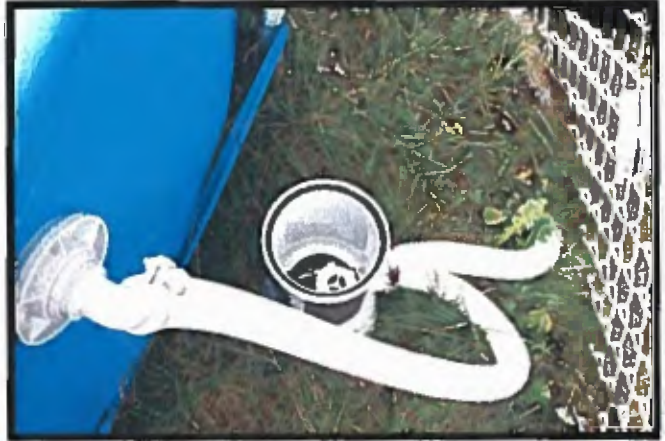
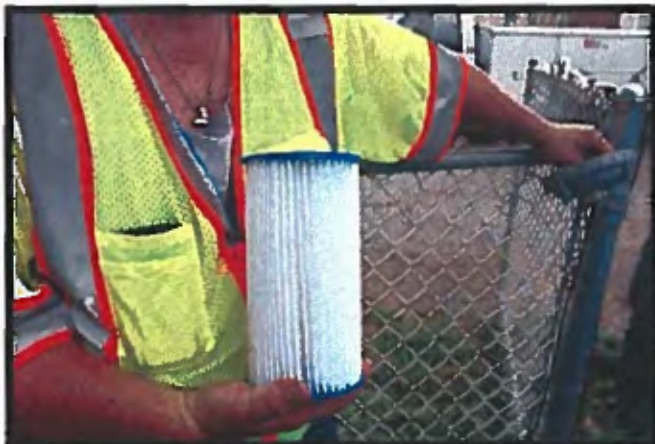
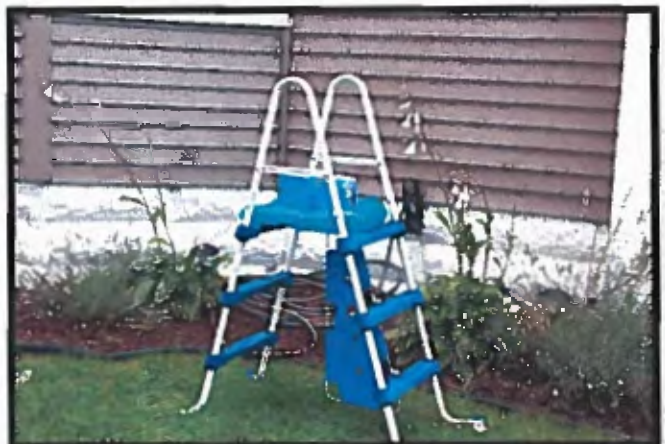
Address: 803 Ohio Ave

Before Photographs

After Photographs

Yes	16	803	Ohio Ave.	Kerr, Brian	7/17/2013	14:15	330-383-8258	MY	Washed pool liner and trampoline. Owner refilled the pool.
No	17	958	St. George St.	Thompson, Shanice	7/17/2013	14:20	330-385-9202	MY	
Yes	18	2484	Stagecoach Rd.	Hager, David	7/17/2013	14:38	330-386-6012	MY	Raymond explained to the owner that the deposition zone was not where his properties are located.
Yes	19	937	St. George St.	Farres, Shuman	7/17/2013	15:14	330-385-2727	MY	Purchased a new air conditioning unit for the homeowner.

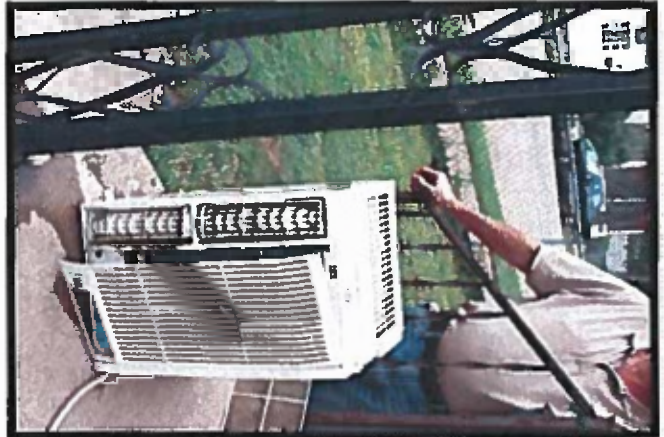
Address: 937 St. George St

Before Photographs

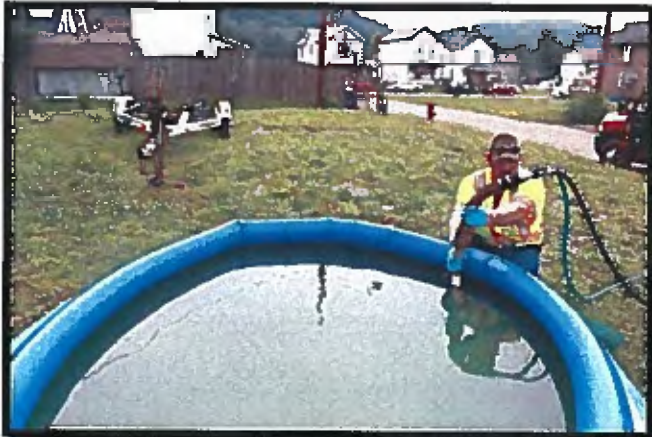
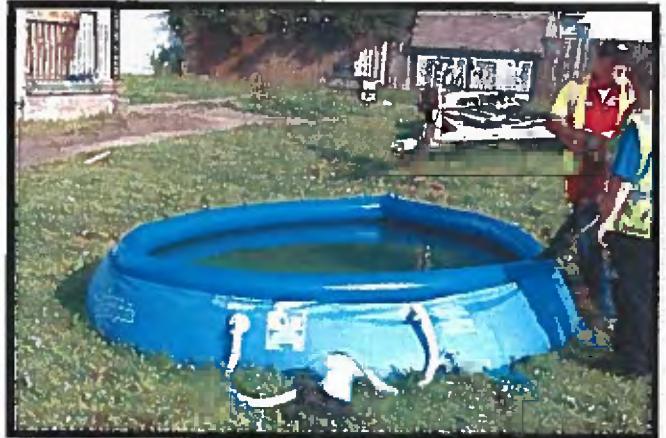
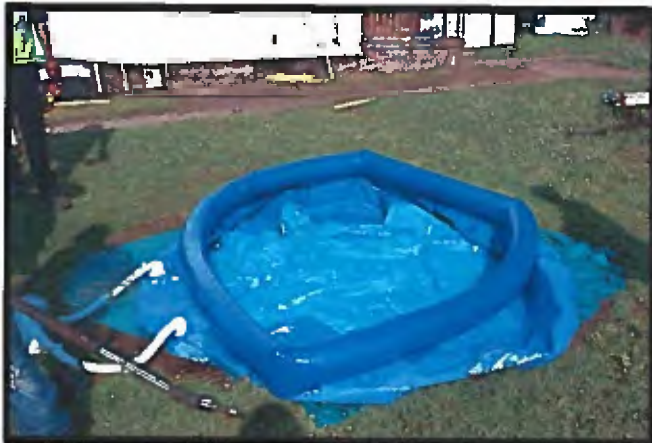
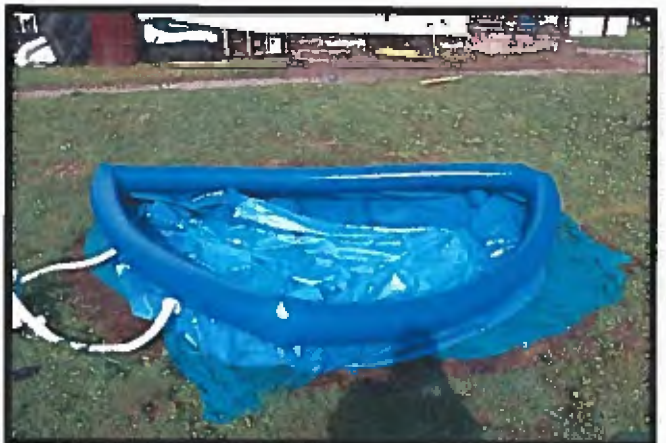
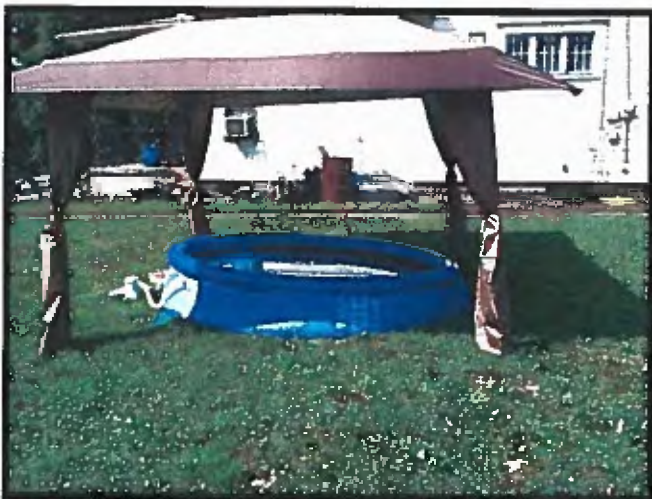
Address: 855 Ohio Avenue

Before Photographs

After Photographs
